EVALUATION OF EPOXIES TO
PROVIDE STRESS-FREE BONDING
OF PYROCERAM MIRRORS.

PREPARED FOR
NIGHT VISION & ELECTRO-OPTICS
LABORATORY, FT. BELVOIR, VA 22060

CONTRACT No. DAAK70-77-C-0186

11
MAR 1979

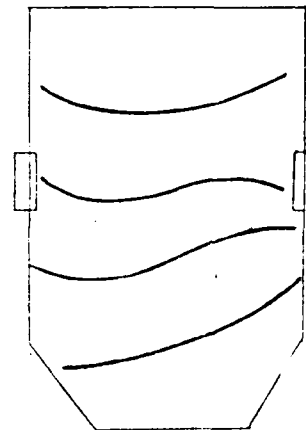
FIGURE 4. FRINGE PATTERNS, VISIBLE SIDE

a) 1 Fringe

b) > 3 Fringes

c) < 1 Fringe

d) > 3 Fringes

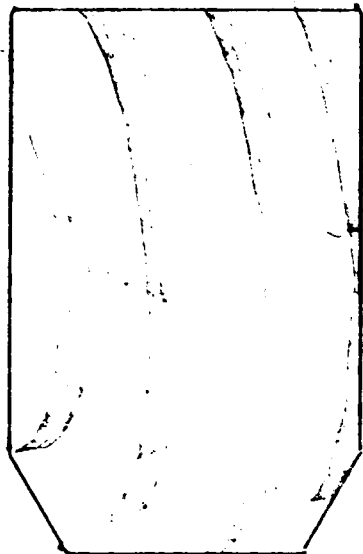
FIGURE 5. TEST MIRROR #1 FRINGE PATTERNS

IR SIDE
 $1\frac{1}{2}$ FRINGE

VISIBLE SIDE
 $1\frac{1}{2}$ FRINGE

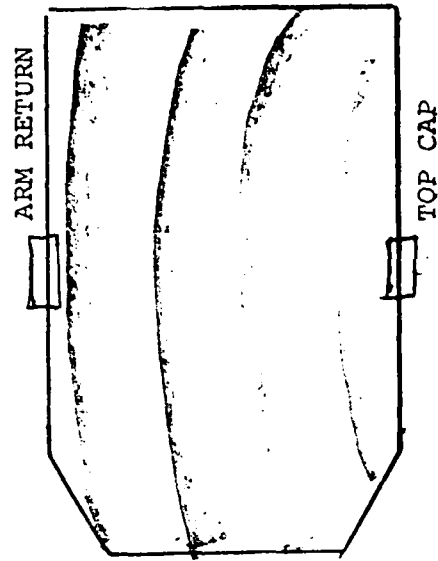
FIGURE 8.. TEST MIRROR #2 FRINGE PATTERNS

Figures 6 and 8 are sketches of the interference patterns obtained after temperature cycling. The mirrors were then tested statically at NVL using their optical test set up.

2 FRINGE

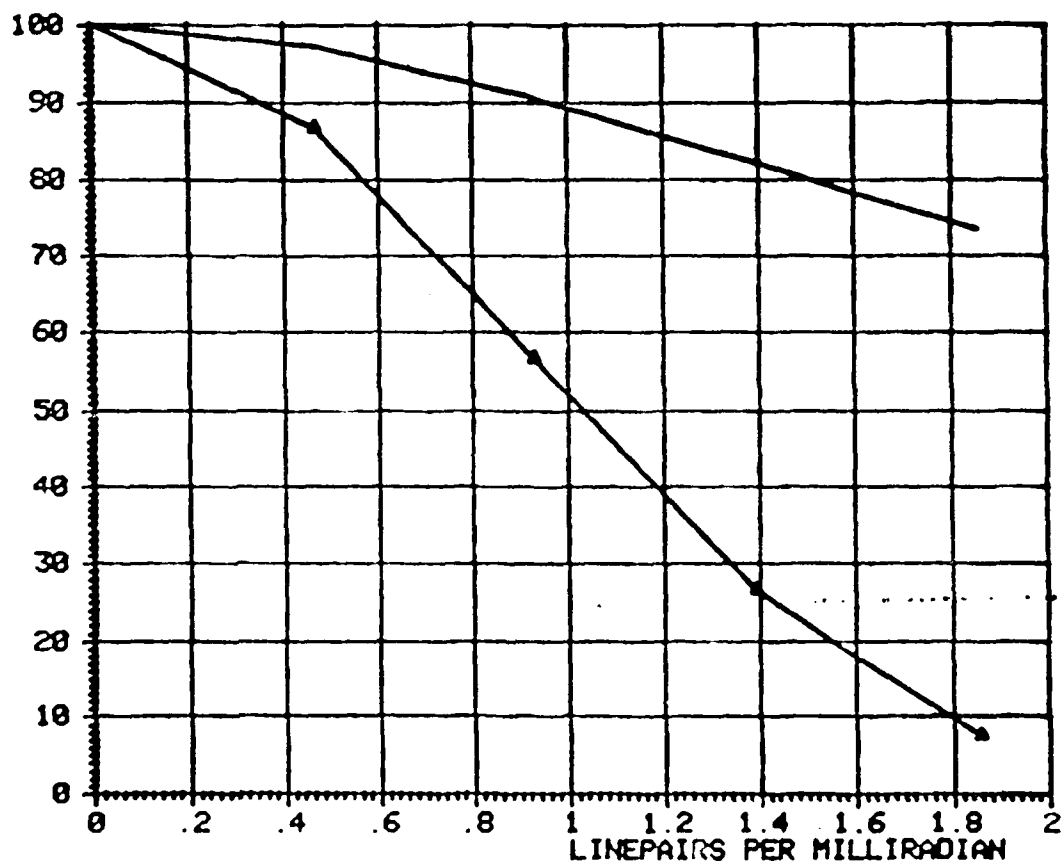
FIGURE 13

Figures 12 and 13 are the printouts of the static MTF curves achieved. In these curves, the azimuth pattern still meets the required MTF limits. However, the elevation pattern shows that there is considerable vertical astigmatism in this mirror. Based on the curves shown in Figures 5-8 for a typical mirror, it was assumed that this astigmatism is a result of assembly.

AEROFLEX SCANNER SERNO 804, IR SIDE POST HEAT TREATMENT 16-AUG-78

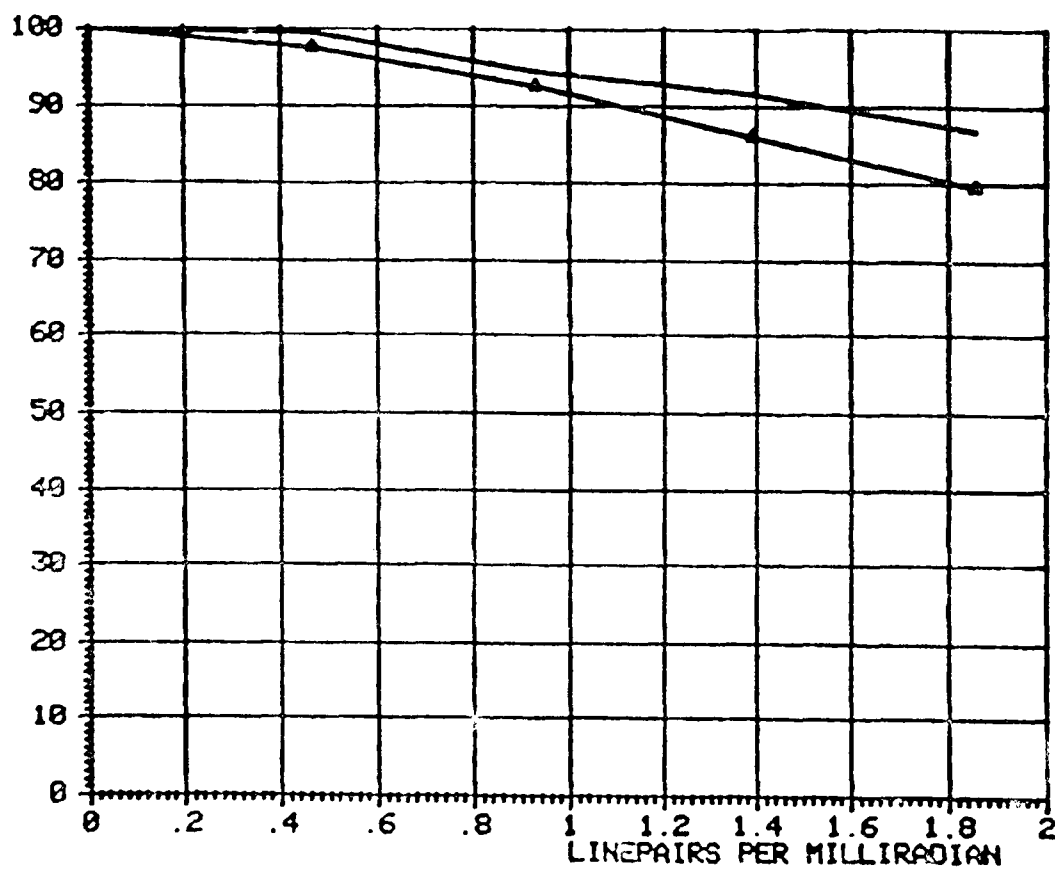
FIGURE 18

Figures 17 and 18 show equally good results on Mirror #002 for the same static test.

AEROFLEX MIRROR ASSEMBLY SN 02 VISIBLR SIDE PST HEAT 16-AUG-78

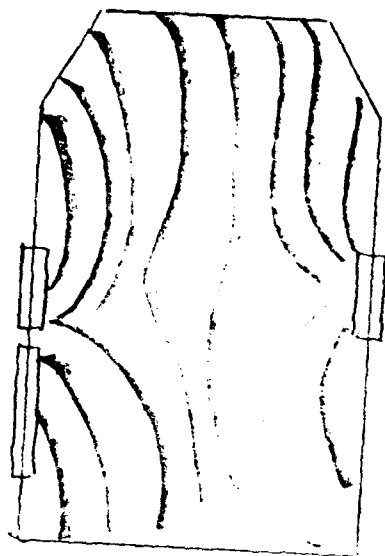
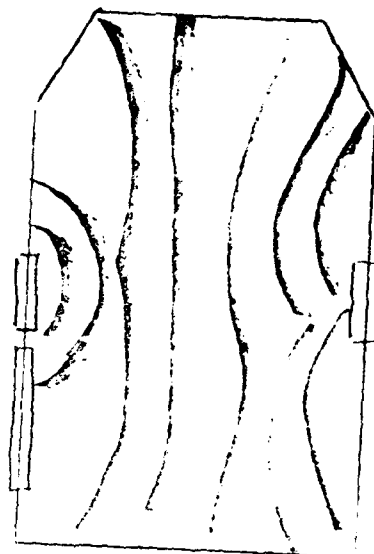
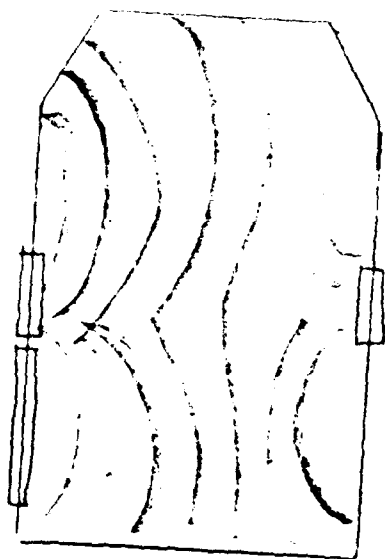
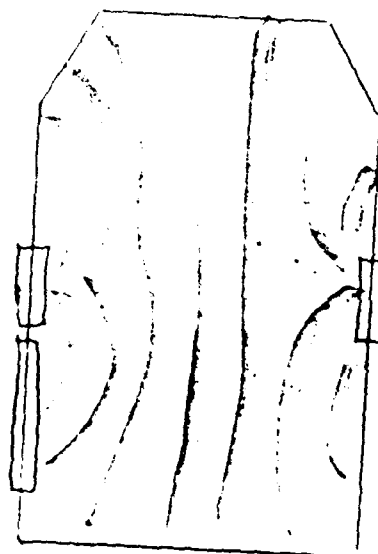
FIGURE 20 FRINGE PATTERNS S/N 004

Serial #004 was then assembled and tested after cycling through the initial and final cementing processes. In this case, there was a small improvement in the distortion over that of #003. However, the patterns show approximately 4 fringes with an irregular pattern. (See Figure 20.)

10/13/78 VISIBLE
4 FRINGE IRREG.

10/19/78 VISIBLE
2-3 FRINGE IRREG.

10/13/78 IR
4 FRINGE IRREG.

10/19/78 IR
2 FRINGE IRREG.

Mirror #004 was rechecked after six days at room temperature. Figure 20 shows that some additional stress relief had occurred in this period. The reason for this could not be determined.

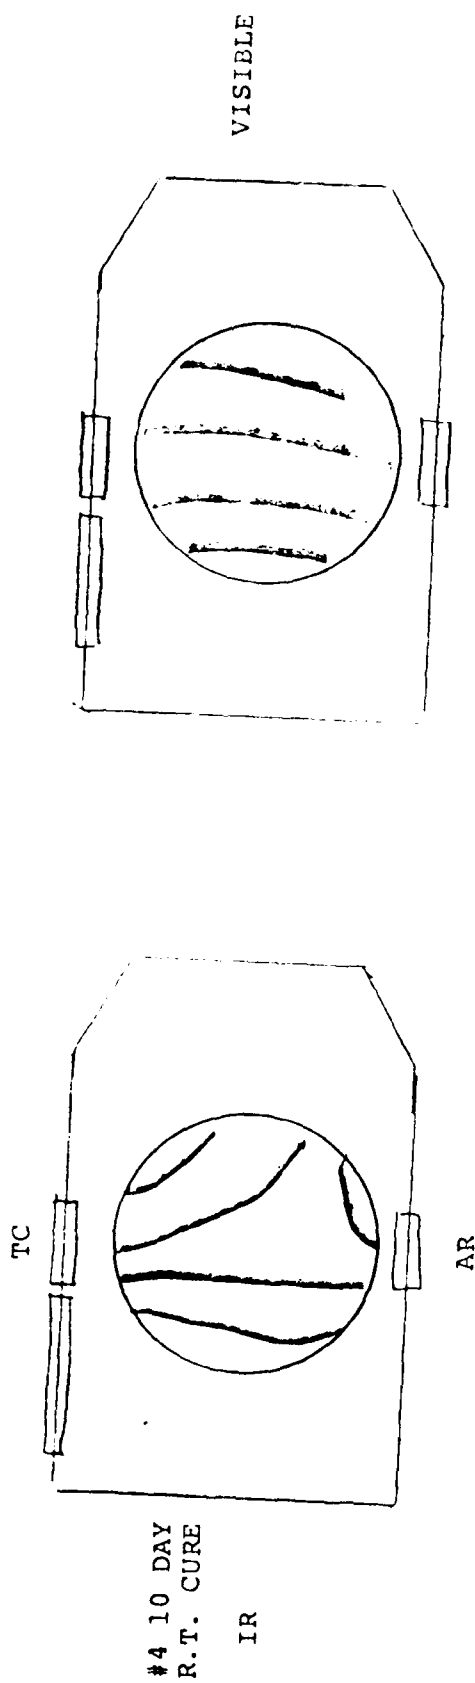
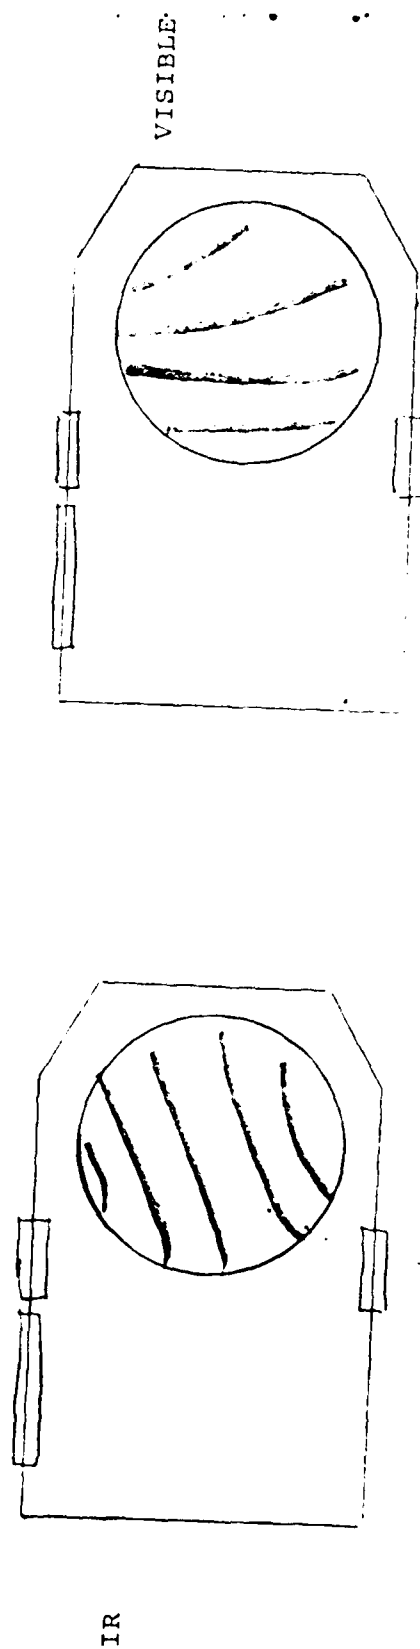
FIGURE 21. FRINGE PATTERNS S/N 004
10 DAY ROOM TEMP AFTER CURE CYCLE

Since there was an obvious change in Mirror #004 stress pattern, a further check was made using an optical flat survey. Figure 21 is a representative sketch of this pattern. The optical flat survey shows some further change but it is difficult to estimate the number of fringes. It was estimated that Mirror #004 showed a fringe response which exceeded the mirror specification.

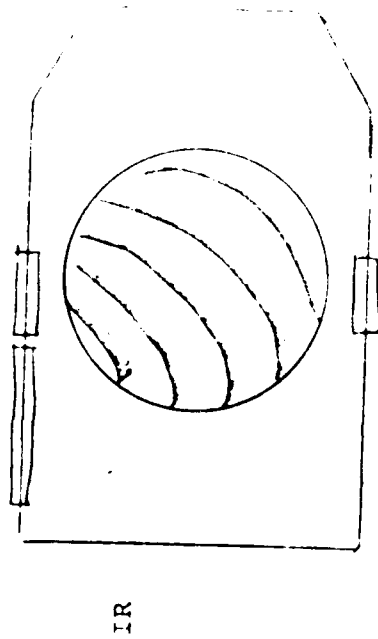
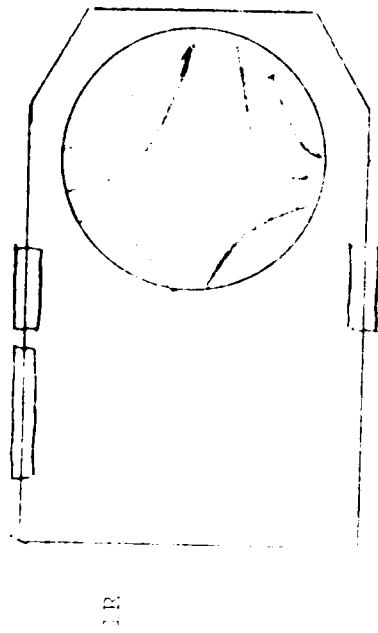
FIGURE 22. FRINGE PATTERNS S/N 005 AFTER FIRST FULL CYCLE
24 HOURS AT ROOM TEMP.

For Mirror #005, the fringe pattern was taken (optical flat survey) after the first room temperature curing cycle. Figure 22 shows a representative pattern.

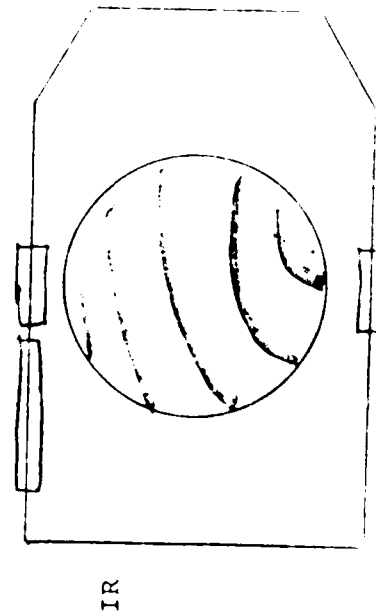
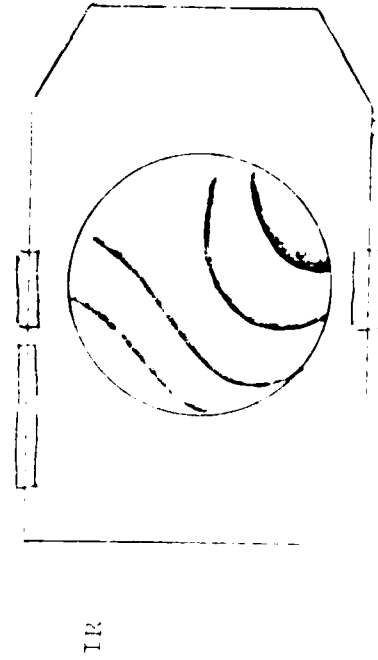
FIGURE 23. FRINGE PATTERNS S/N 009
AFTER FIRST FULL CYCLE NOT STRESS RELIEVED

On Mirror #005, the temperature cycle recommended by NVL was interrupted after the polymerization cycle and an optical flat survey was made of both sides. There was an indication of stress caused by the cement on both the top cap and the arm return. This stress showed in an irregular pattern of about 3 fringes. (Figure 23.)

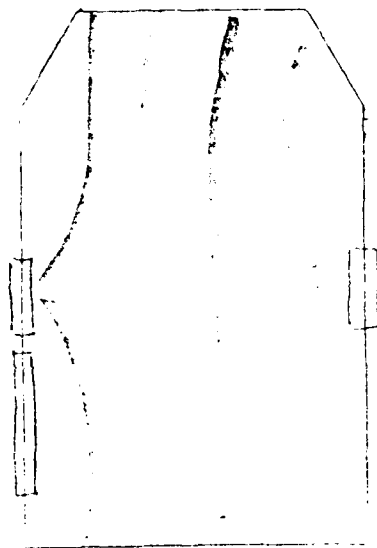
FIGURE 24. FRINGE PATTERNS S/N 005
AFTER FULL CURE CYCLE

The temperature cycling was then completed by going through the low temperature (-62°C) and then high ($+95^{\circ}\text{C}$) for four hours at each temperature. Upon completion of this cycle the mirror was surveyed using an optical flat and a definite improvement in the number of fringes was observed (see Figure #24). However, there is still a basic irregularity to the mirror surface near the metal parts with a more regular area towards the center of the mirror. On this basis, the mirror was tested for MTF in order to establish a correlation between fringe patterns and MTF response. As shown in later tests, this correlation has not been found.

2-3 CYLINDRICAL

1-2 FRINGE IRREG.
3 ARM RETURN

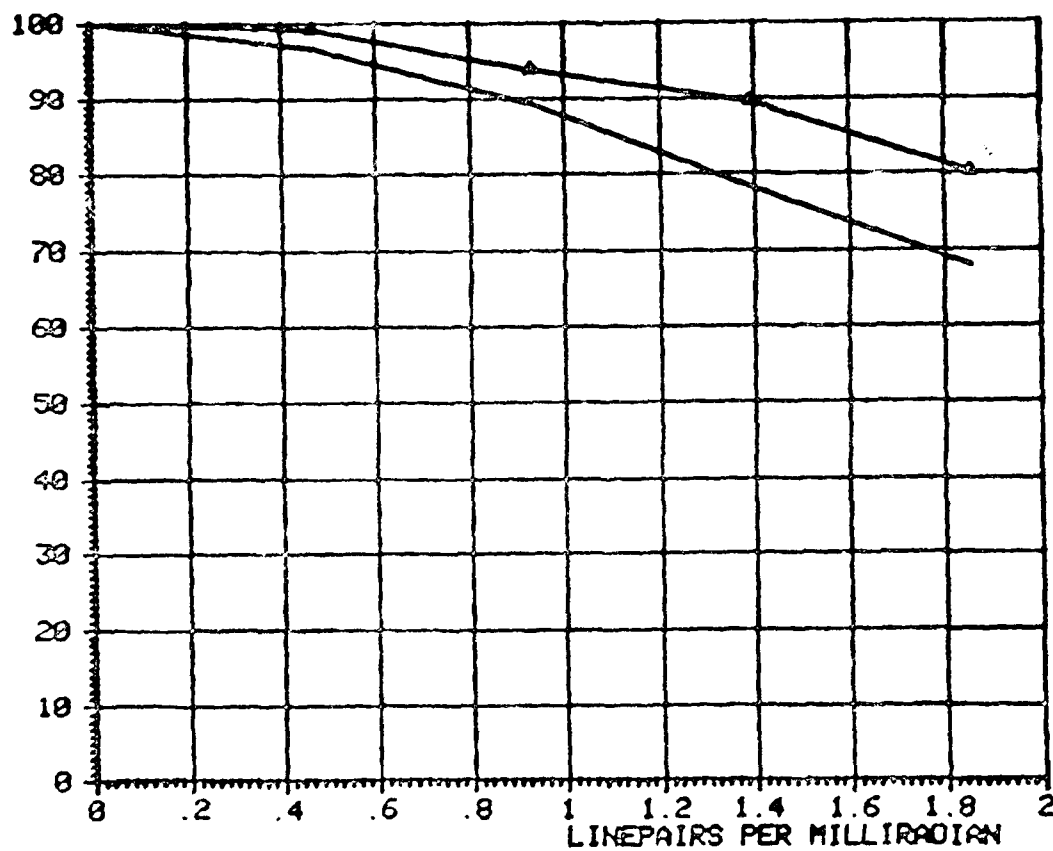
FIGURE 27. MTF RESPONSE, S/N 004, I R SIDE

Figure 23 shows very little change in the MTF characteristic described previously. The conclusion that was drawn from this set of runs on the IR side was that the number of overall fringes just exceeds the value acceptable for the mirror assembly to pass the MTF test requirements.

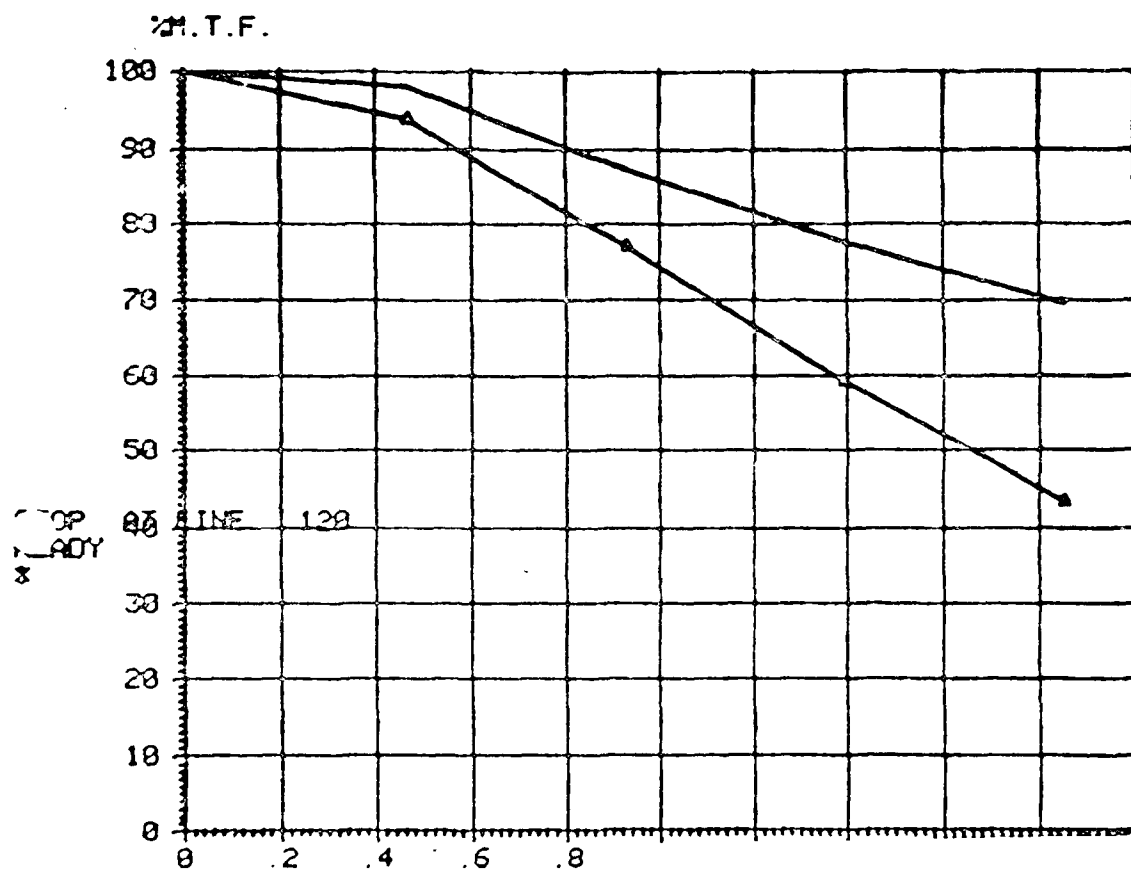
FIGURE 38. MTF RESPONSE, S/N 006, VISIBLE SIDE

The MTF equipment was refocused to see if a more optimum focal point could be achieved. In this case, the azimuthal and elevation planes reversed themselves with similar patterns. The MTF was then taken on the Visible side (Figure 38) and although the surface showed astigmatism, the elevation plane again failed to meet the requirement by a considerable margin and the azimuthal plane also fell below requirements. The test equipment was refocused again with the response shown in Figure 39 resulting.

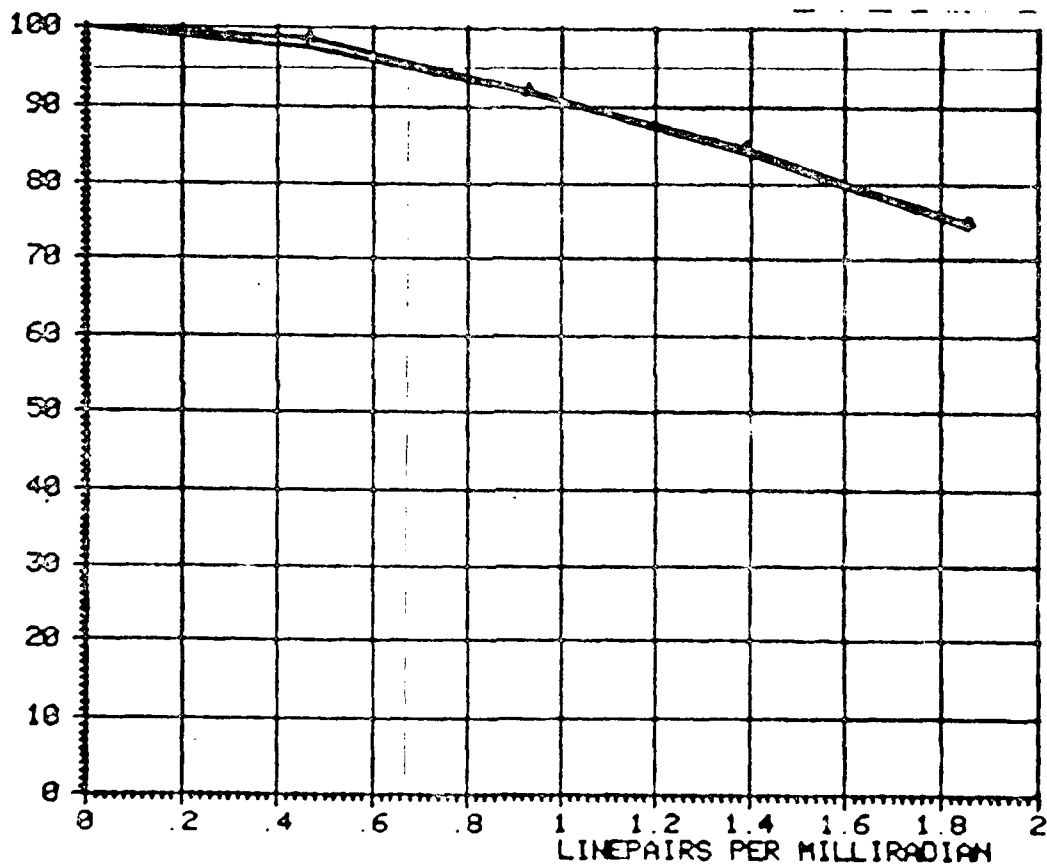
FIGURE 43. MTF RESPONSE, S/N 007, I R SIDE

A plot of the MTF achieved for the IR side is shown in Figure 43. In this case, the mirror passes the MTF requirements with an indication of some astigmatism in the azimuthal plane. The focus was readjusted from the point at which the first MTF was taken and Figure 44 is a plot of the second MTF achieved. In this case, the astigmatism is more clearly defined with the mirror achieving the required MTF azimuthally but shows that adjustment of the focal point between sagittal and tangential focus improved the elevation pattern. For the

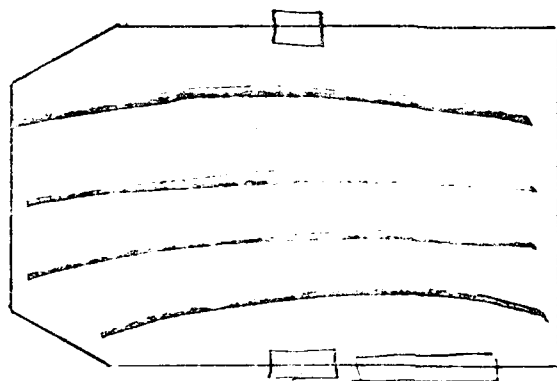
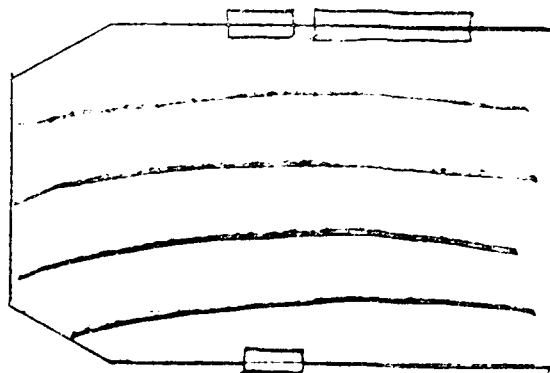
Mirror #008 was assembled and was carefully controlled at every point in the assembly process. As in #007, all stress points were removed and an optical check was made as the assembly was completed. Under this condition, the mirror was checked before the heat treat cycle (see Figure 46) with a resultant fringe pattern of $1/2$ to 1 fringe regular being

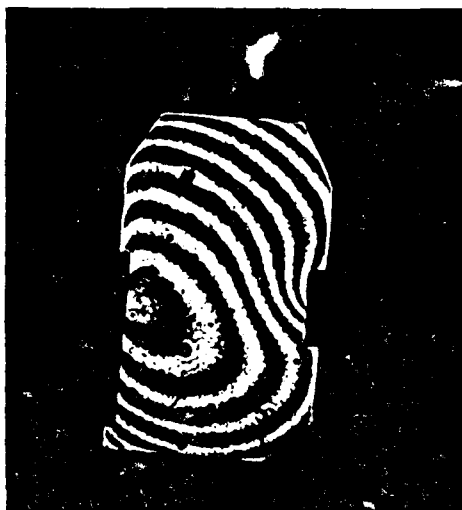
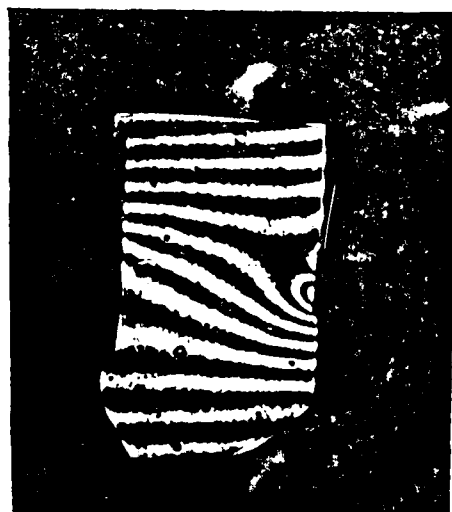
FIGURE 47. INTERFEROGRAMS, S/N 008

exhibited by both sides of the mirror. This unit was then subjected to the NVL temperature cycle and over the central portion showed a considerable shift from the previous pattern exhibited before temperature cycling (Figure 47). In this case, the top cap still showed distortion patterns which were greater than that shown on the arm return side. A rough estimate of the number of fringes using an optical flat surface showed approximately 2 fringes or more with some irregularity being evidenced on both sides.

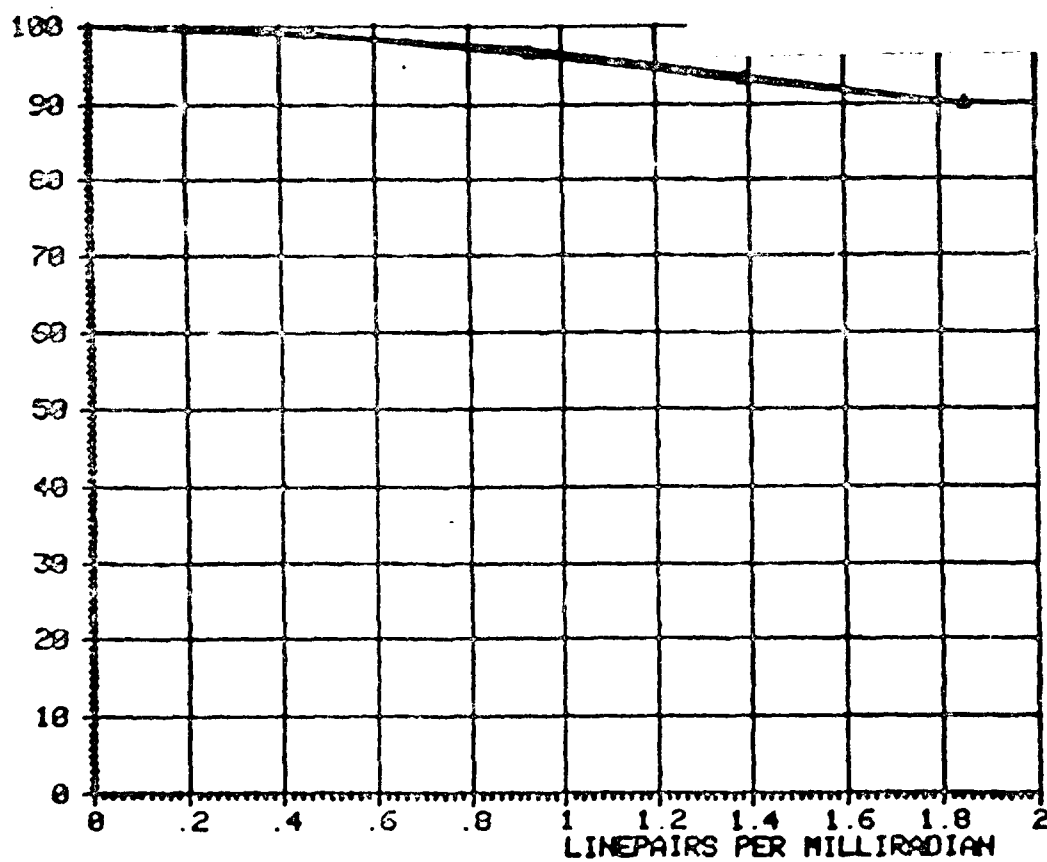
The mirror was then subjected to a MTF test at the NVL facility and Figures 48 and 49 reflect the response of this mirror. The curves achieved for the MTF test indicated that the Visual side showed essentially no astigmatism with a regular elliptical surface in evidence. The IR side shows that the elevation plane response was somewhat better than that of the azimuthal response with some astigmatism involved. It is difficult to interpret the interferogram shown on Figure 47 to determine that this astigmatism is there. However, it becomes evident that the response of the mirror from an interferogram point of view can be misinterpreted to a considerable degree, especially to an inexperienced eye.

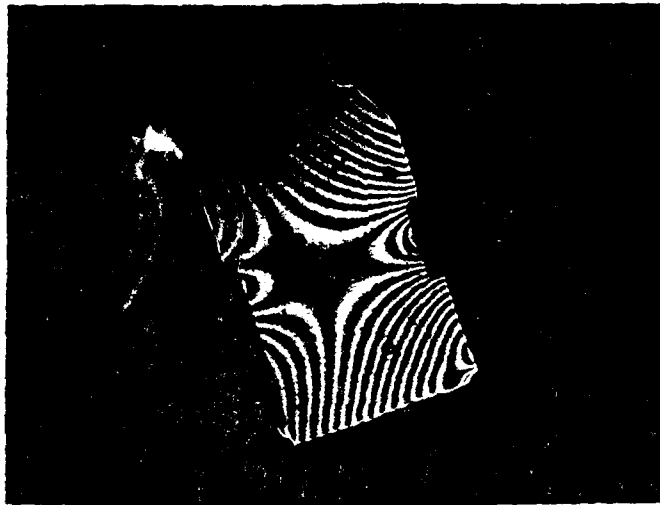
Mirror #009 was assembled and the results achieved on this and subsequent mirrors showed that there were still many variables involved with the use of the Stycast epoxy which are uncontrolled or uncontrollable. Figure 53 is a set of interferograms for both the IR and Visible sides and shows considerable saddling at the mounting points for both the arm return and top cap parts. It should be borne in mind that this mirror was assembled using the same fixture with all of the stress points relieved before and during initial cementing. In spite of this, a $1/4$ to $1/2$ fringe mirror ended up with the distortion shown in Figure 53. Prior to the temperature cycle and after at least 24 hours of air cure, this mirror showed practically no distortion on either side.

Figure 54 is a plot of the MTF response achieved and shows a very poor performance. This was to be expected considering the interferogram shown on Figure 53, but the quantitative degradation in MTF could not be predicted.

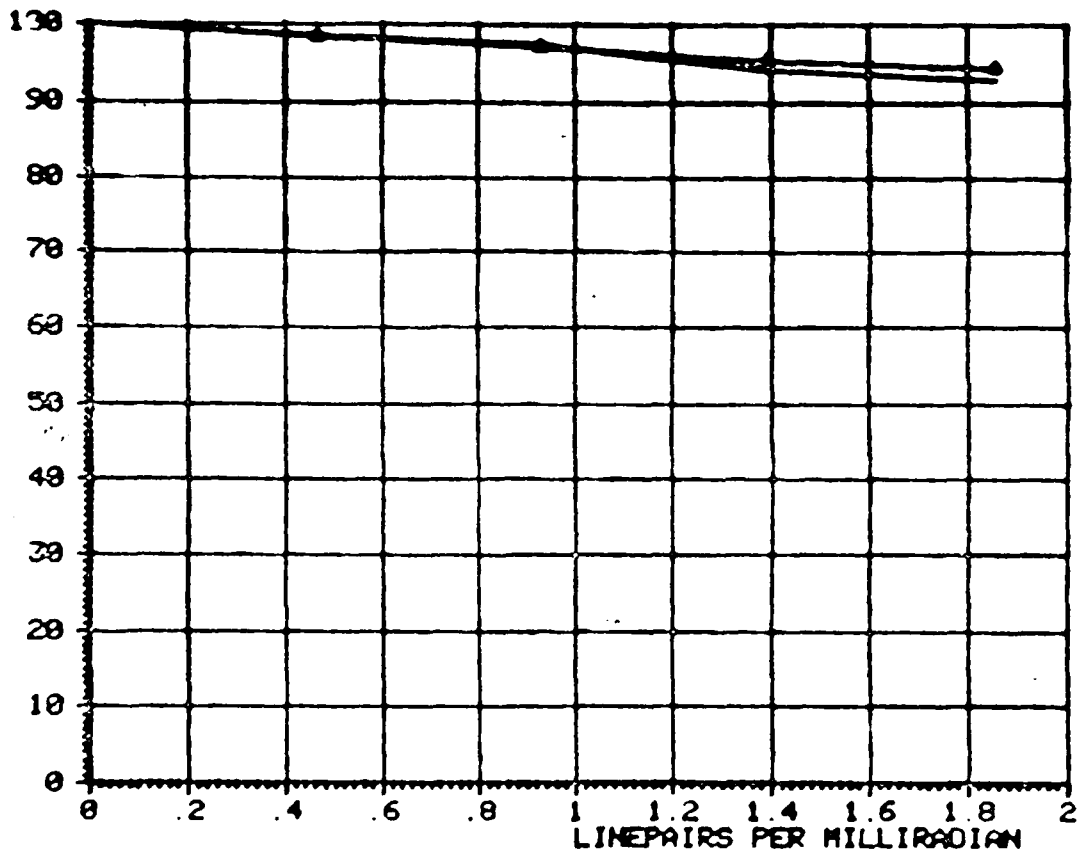
FIGURE 58. MTF RESPONSE, VISIBLE SIDE, S/N 009A

Figure 58 is a plot of the MTF response of the Visible side. This side has more than exceeded the specification requirements and in general the results are dramatic compared to Mirror #009, using exactly the same assembly techniques and procedures.

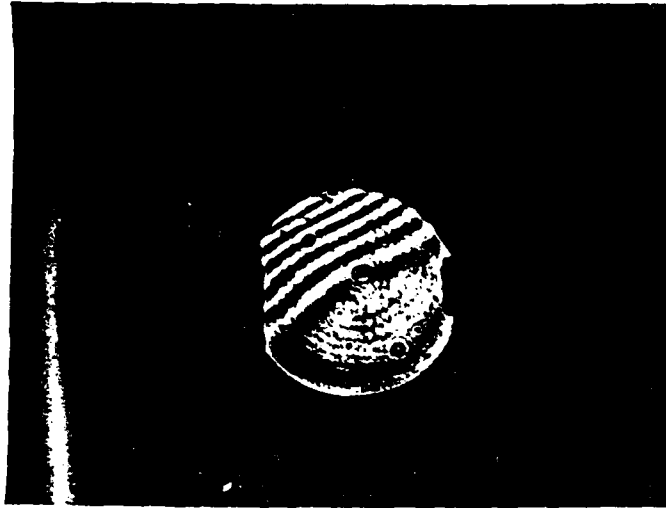
FIGURE 70. INTERFEROGRAMS, MIRROR #009B AFTER 4 HOUR OPERATION @ 98°C

mirror surfaces using a laser interferometer. The infra red side shows a saddling pattern and was cause for considerable concern. However, re-examination of the interferogram indicated that although the surface is saddled, the depth of the saddle is small (approximately 1 fringe or about 5×10^{-6} in). This depth or variation from a true surface is insufficient to cause a significant change in the MTF response. As it turns out, the MTF response was quite good (to the relief of all concerned). Once again a casual examination of the interferogram was misleading. The visible side showed a small change from the original fringe pattern but is still regular. Closer examination of the pattern shows that the surface is cylindrical and would result in slight astigmatism. The MTF response reflects this.

Upon completion of the dynamic tests, the scanner was turned off and static MTF tests were run on the mirror as well. Figure 74 shows the IR static response and as can be seen, the astigmatism is virtually zero for this side. This again apparently conflicts with the interferogram shown in Figure 70 for this side. While the dynamic response effectively gives the MTF for the azimuthal plane and would eliminate any elevational astigmatism, the static response is designed to show this difference. Figure 74 indicates that the depth of the saddle can be no more than one fringe.

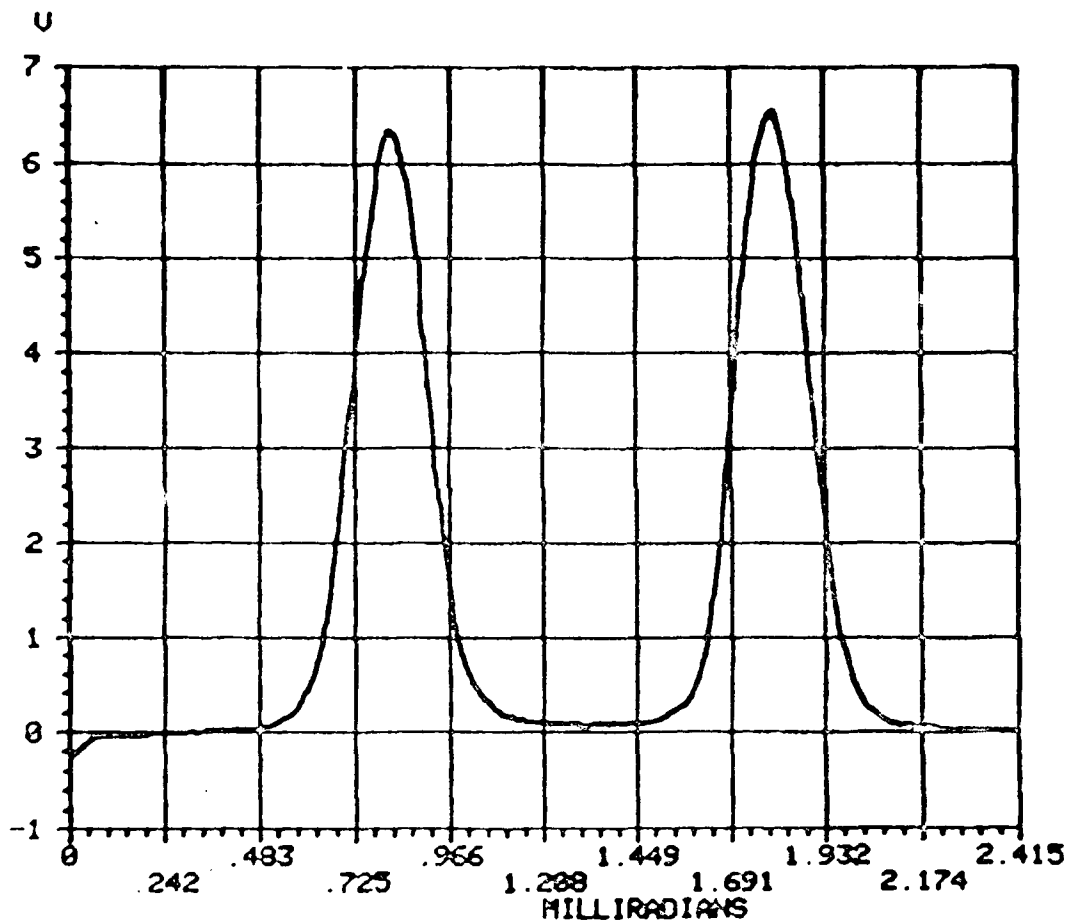
FIGURE 71. CALIBRATION CURVE, DYNAMIC MTF, SCANNER #003,
MIRROR #009B

A dynamic MTF test was then run on this mirror. Figure 71 is the calibration curve obtained during this test. Figure 72 is a plot of the IR side MTF response. The response is certainly well within the specified limits and but for the depth of the saddle would not reflect what would be expected with the interferogram shown in Figure 73. All that could be said at this stage was that the mirror performance was far superior to that anticipated for this type of interferogram.

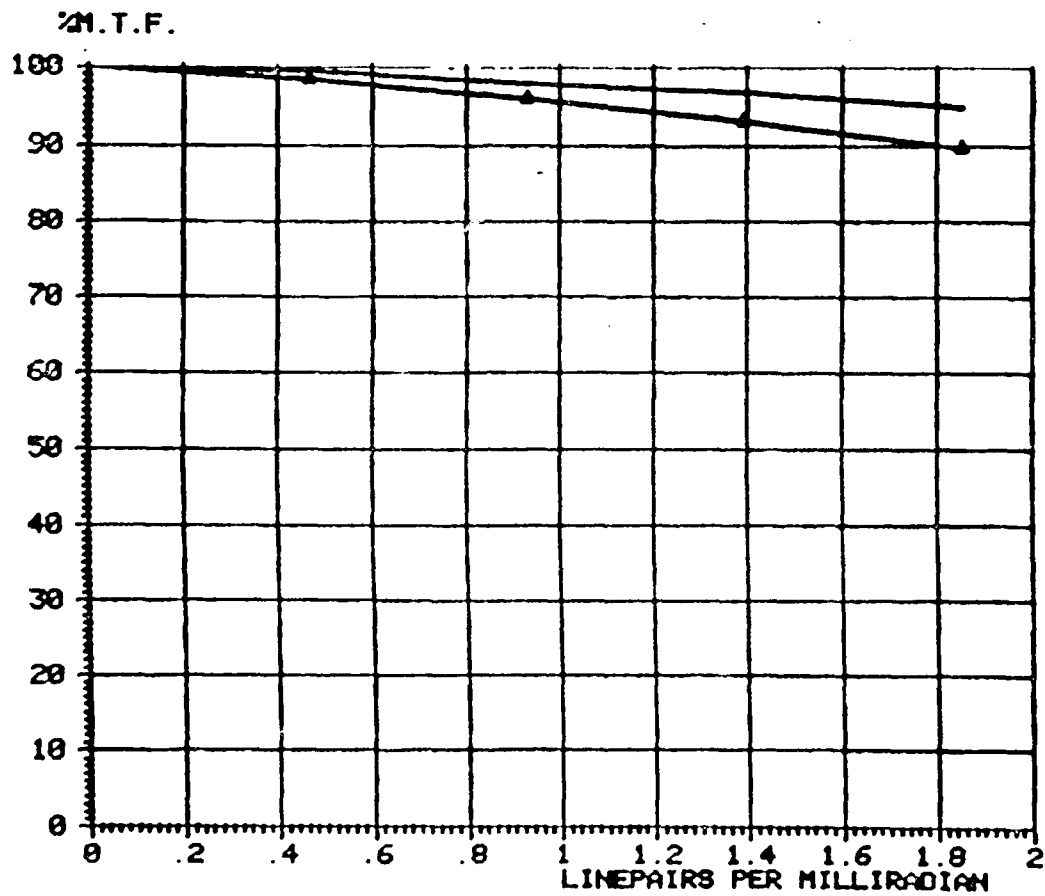
The MTF responses shown in Figures 80 and 81 show that the mirrors met the requirements. Moreover in this case the Visible side shows an attendant astigmatism which is consistent with the ellipticity shown in Figure 79.

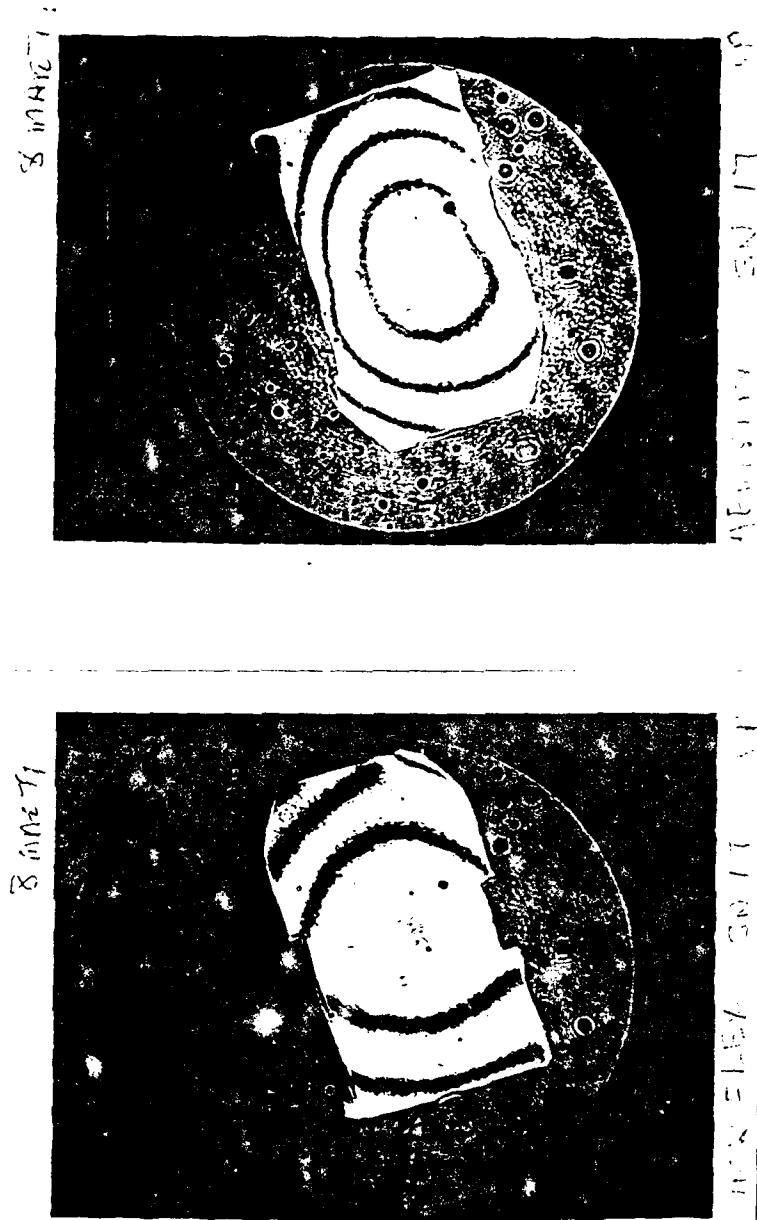
FIGURE 92. INTERFEROGRAMS, S/N 017

Figure 92 is a set of interferograms taken on Mirror #017 after the NVL heat treat cycle. This mirror was assembled using MilBond cement. As shown, the mirror exhibits a regular but somewhat spherical surface. The IR side shows about 1-1/2 fringes and the Visible about 1 fringe after heat cycling.

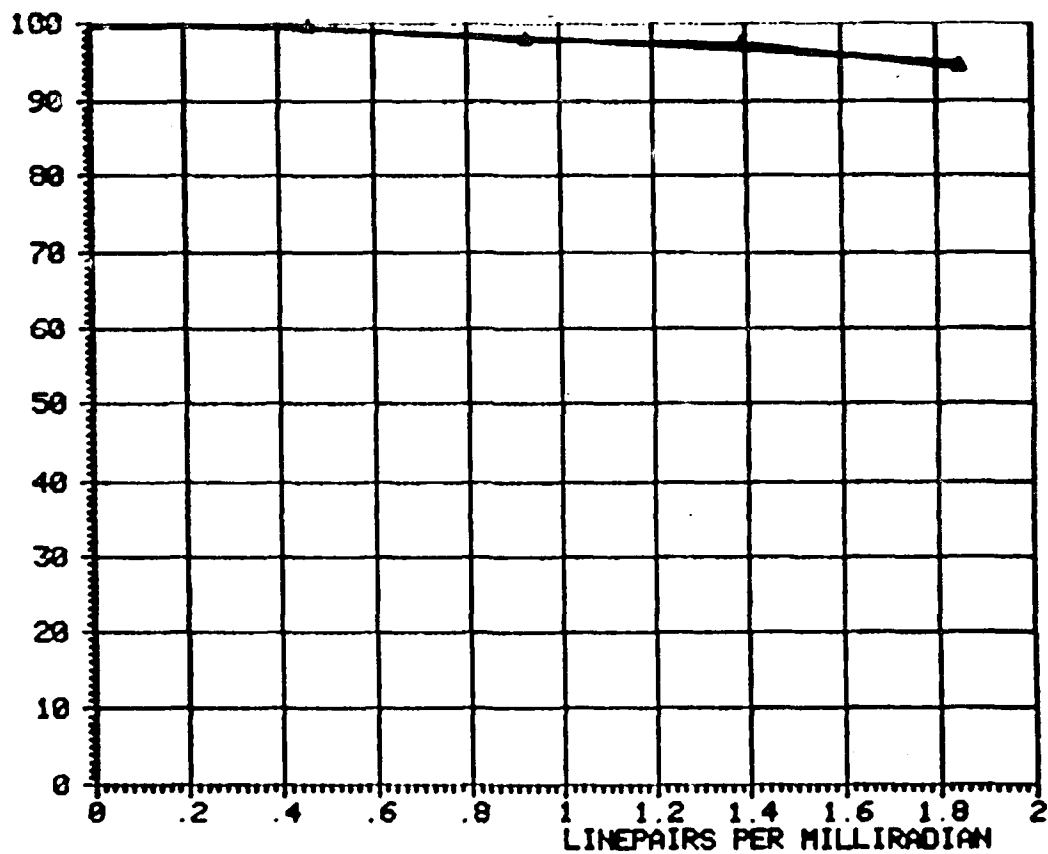
FIGURE 93. MTF RESPONSE, IR SIDE S/N 017

The resultant MTF responses are excellent. Figure 93 is a plot of the IR side response with an MTF of .95 or better at 1.6 Lp/mr with no astigmatism. Figure 94 is a plot of the Visible side with an MTF of .95 to about 1.55 Lp/mr and mirror astigmatism.

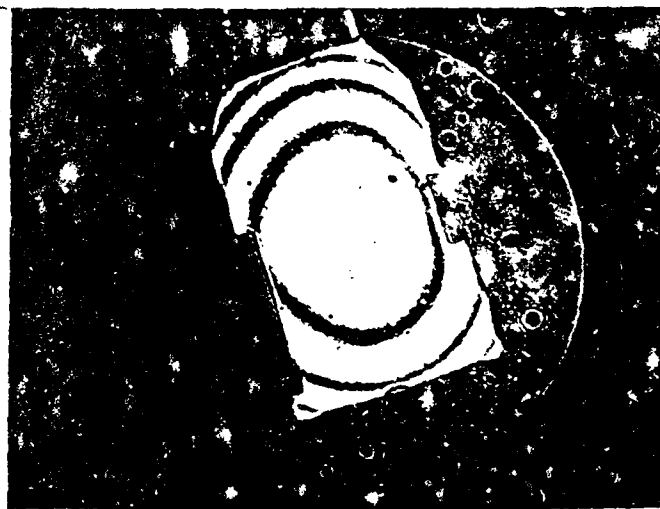
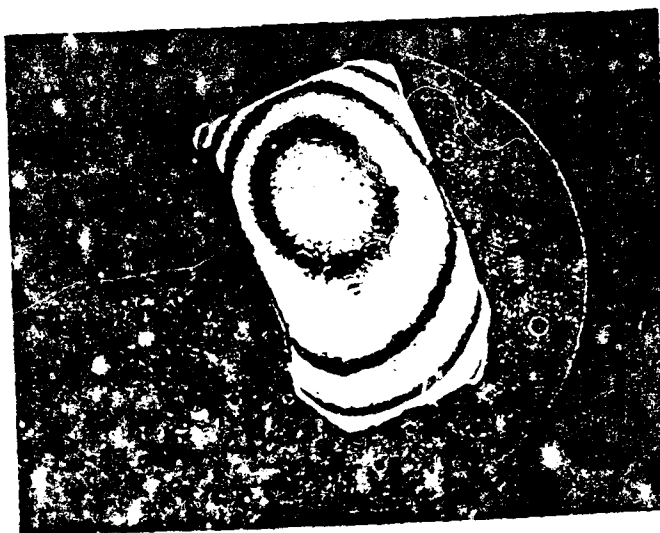
FIGURE 95. INTERFEROGRAMS, S/N 018

Figure 95 is a set of interferograms taken on Mirror #018. In this case, both sides are regular and spherical. The IR side shows about 2 fringes. The Visible side shows about 1-1/2 fringes worst case.

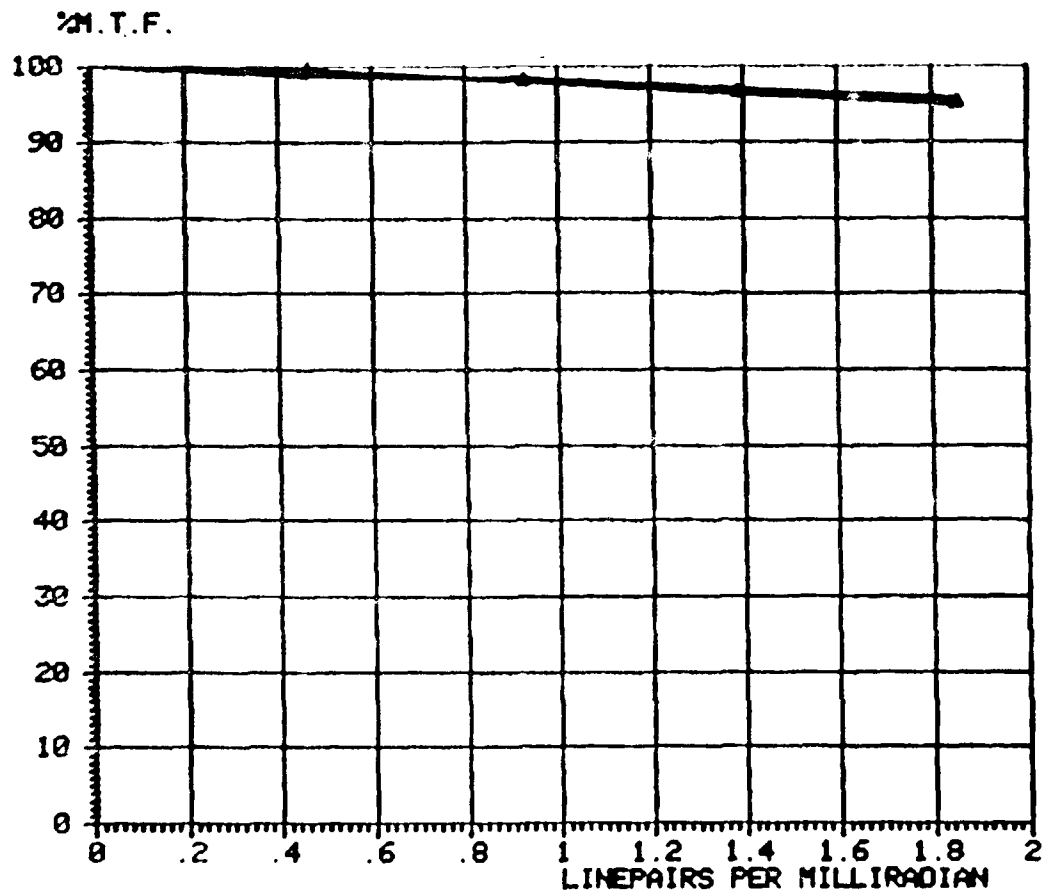
FIGURE 96. MTF RESPONSE, IR SIDE, S/N 018

The resultant MTF responses are also excellent. Figure 96 is a plot of the IR side response. Here the MTF passes .95 at 1/8 Lp/mr with no apparent astigmatism.

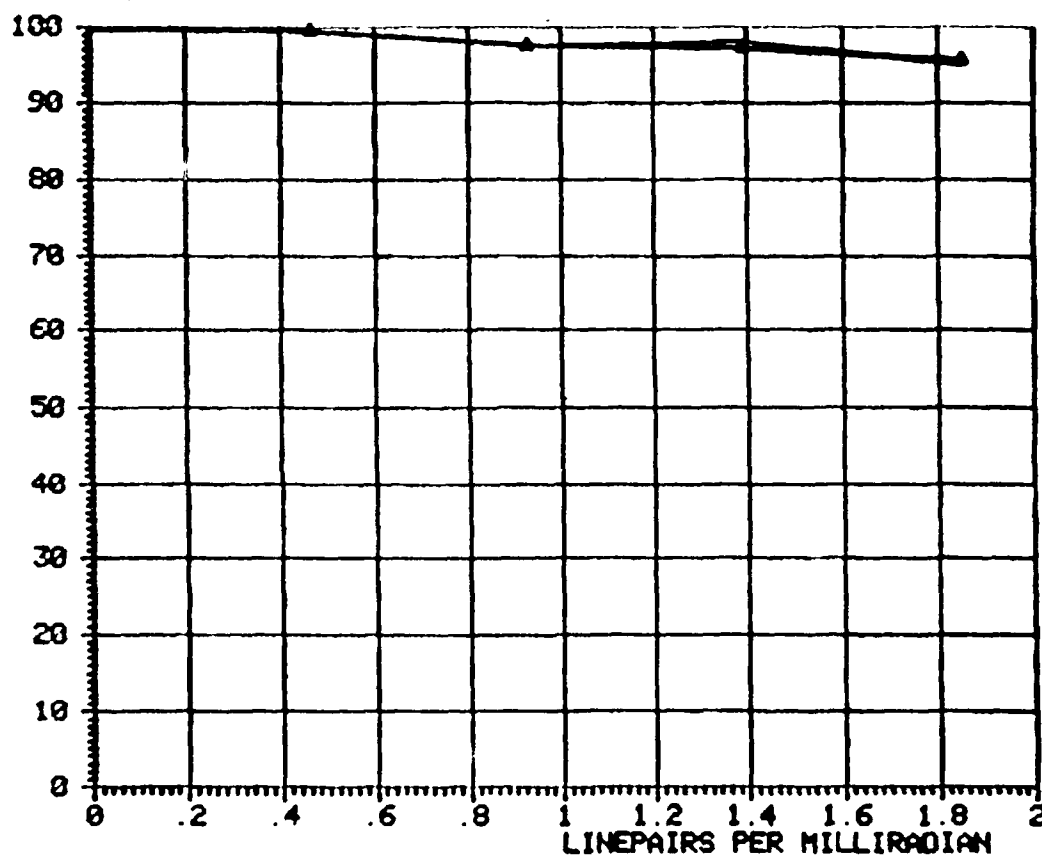
FIGURE 97. MTF RESPONSE, IR SIDE, S/N 018

Similarly, Figure 97 shows that the Visible side has an MTF of .95 to at least 1.8 Lp/mm.
